Keeping OS/OW Freight Moving = Work Zone Mitigation

Monona Terrace Convention Center
October 18, 2011

Presented by: Randy Hoyt, PE

OS/OW Work Zone Mitigation

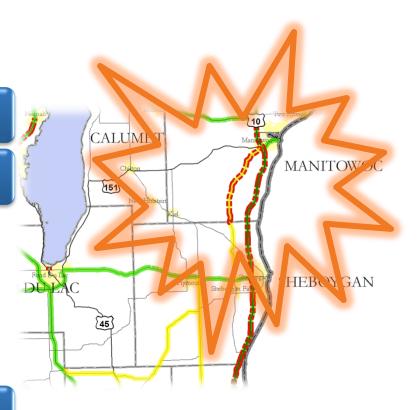
WIS 42 & I-43 Manitowoc County

- WIS 42
 - Full closure
 - Detour was I-43
- I-43
 - Several bridge decking projects
 - Bi-directional traffic

Major wind load corridor

Loads originate in Manitowoc & Port of Menomonee Michigan

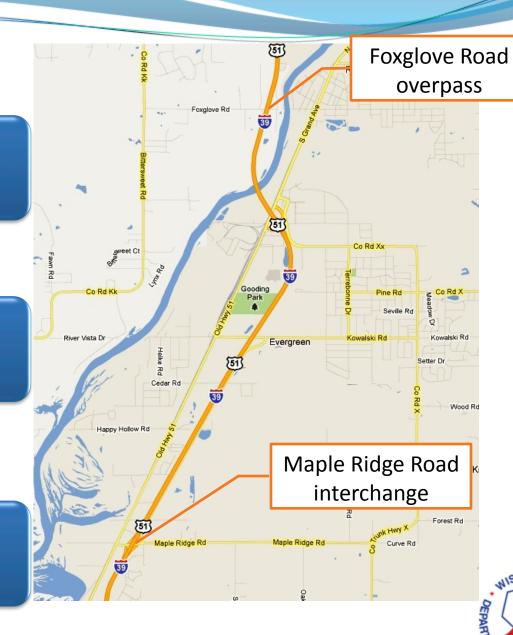
2 Wausau Area Bridges

Foxglove Road overpass

- Low vertical clearance
- Impassable by most OS/OW loads
- Scheduled for 2012 replacement

Maple Ridge Road interchange

- Low vertical clearance
- Diamond interchange
- OS/OW able to 'ramp off/ramp on'
- Scheduled for 2011 replacement

Working with the DOT region planning staff, Foxglove replacement was accelerated

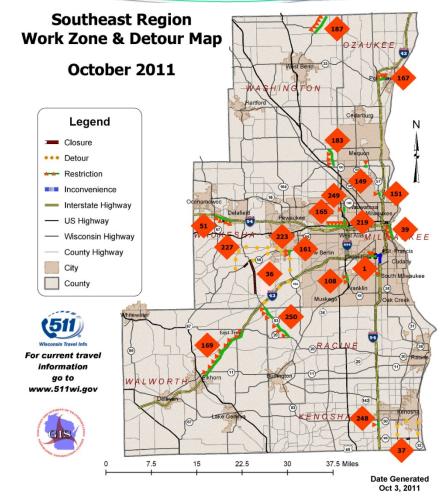
Monthly Work Zone Map

Map all projects >6 days

Includes detour information

Detailed monthly view

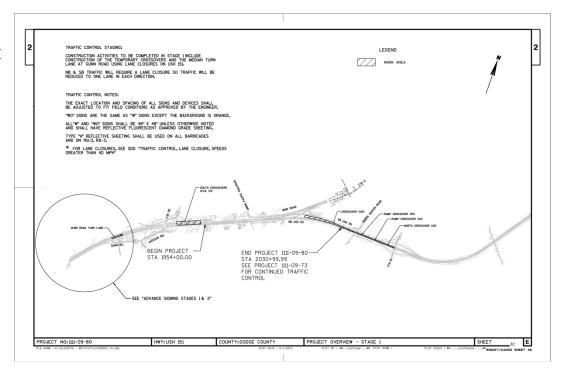
- •US 151 in Beaver Dam, Wis.
 - •Primary southbound wind route to Illinois and points west
 - •Reconstruction includes:
 - Crossovers
 - •Bi-directional flow
- •Plan called for 2-12' lanes with 2' shoulders, 1' shy distance
 - •Separated by flexible tubular markers
- •Wind tower base sections traveling through measured 15' wide

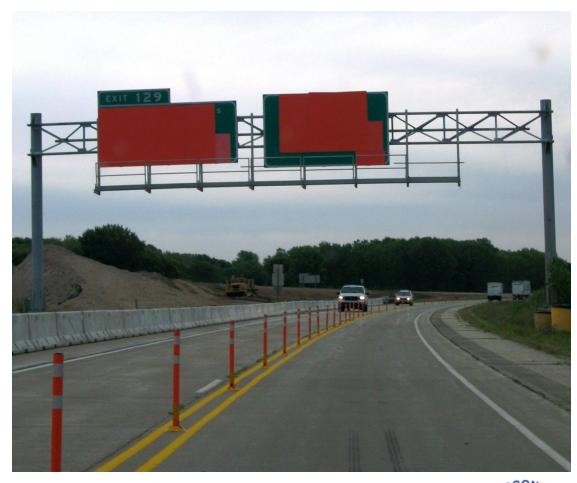
- •Met with project superintendent, DOT project staff
- •Arranged to have a 13' lane southbound, 11' lane northbound
- •Changes amounted to ordering new lane width warning signs

Looking northbound: Center line offset 1'
