Impact of Overweight Vehicles (with Heavy Axle Loads) on Bridge Deck Deterioration

CFIRE 04-06
March 2012

Final Report

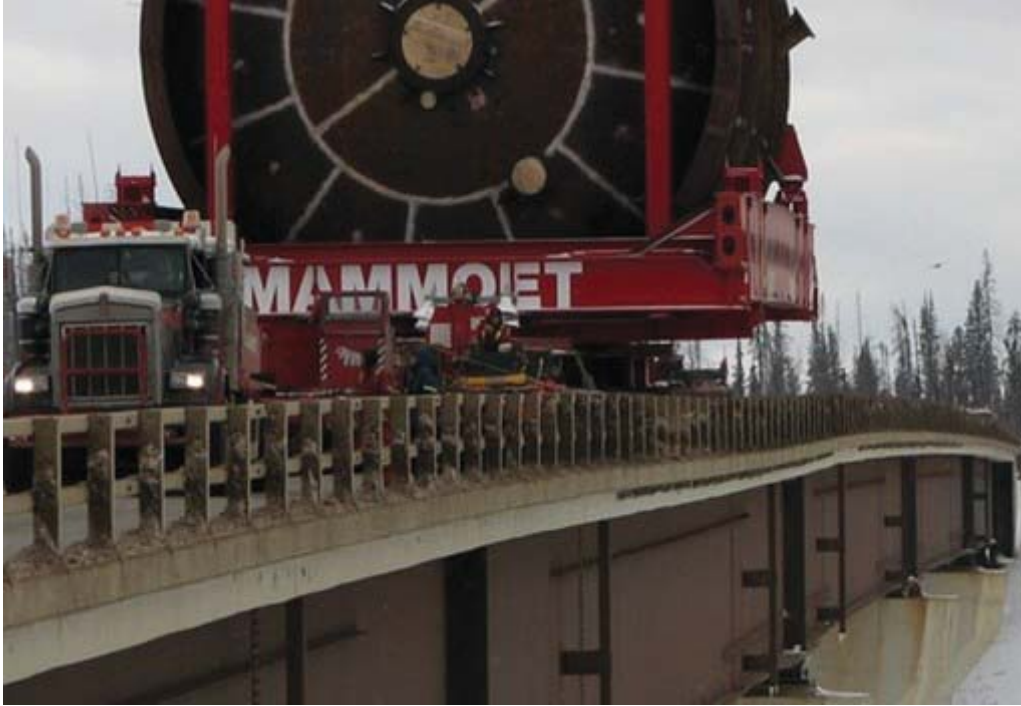
Figure 1.1: Overweight vehicle on a bridge (Foley, 2007)

The stresses in bridge decks can be significantly increased when a bridge is loaded by overweight vehicles, as illustrated in Figure 1.1. The overweight vehicle caused large, visible deflection in the steel girder bridge, indicating an elevated level of bending moments and internal stresses, in both tension and compression, in the bridge deck. In addition, some studies have indicated that axle weights are more important indicators of deck damage than gross vehicle weights (Laman and Ashbaugh, 2000; Boothby and Laman, 1999). With these loads, the compressive stresses can be high enough to cause internal damage (i.e., micro-cracking) to the bridge deck. The micro-cracking in concrete may increase the permeability of the concrete and accelerate the deterioration of bridge decks. Thus, the stress-induced microcracks play an essential role in permeability of concrete and reviewed as detailed in the following section.

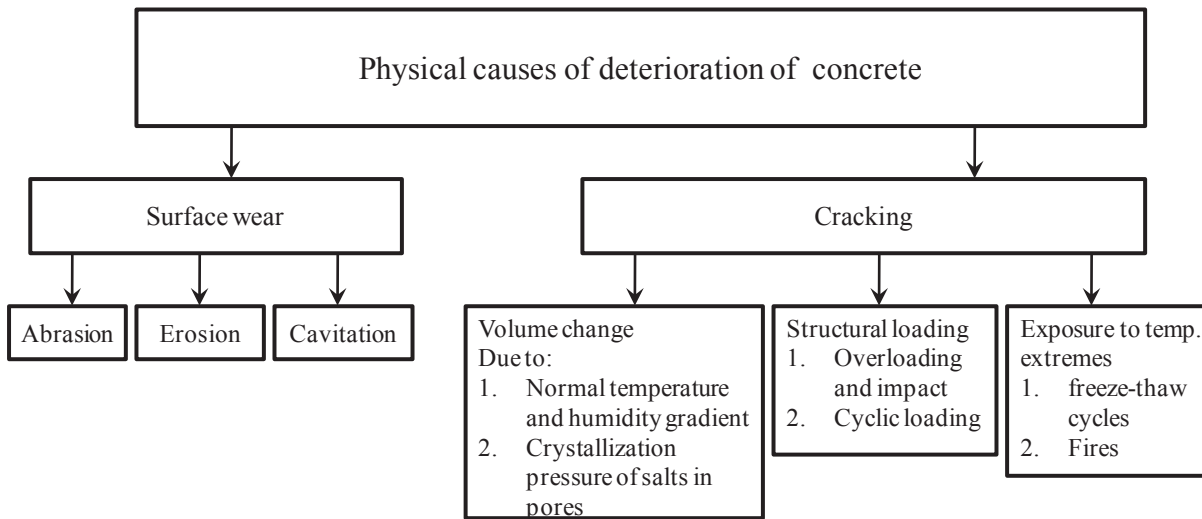
Figure 2.3: Physical causes of concrete deterioration (Mehta and Gerwick, 1982)

The permeability of concrete can be affected by the microcracks in the concrete due to temperature gradients, structural loading, and freeze-thaw actions, as illustrated in Figure 2.3. As a result, the structural loading and freeze-thaw cycles may be coupled with the processes of chemical deterioration (Mehta and Monteiro, 2006). In addition, temperature, the distribution and width of microcracks/cracks, and environmental conditions, affect the substance flowing and thus affect the permeability of concrete.

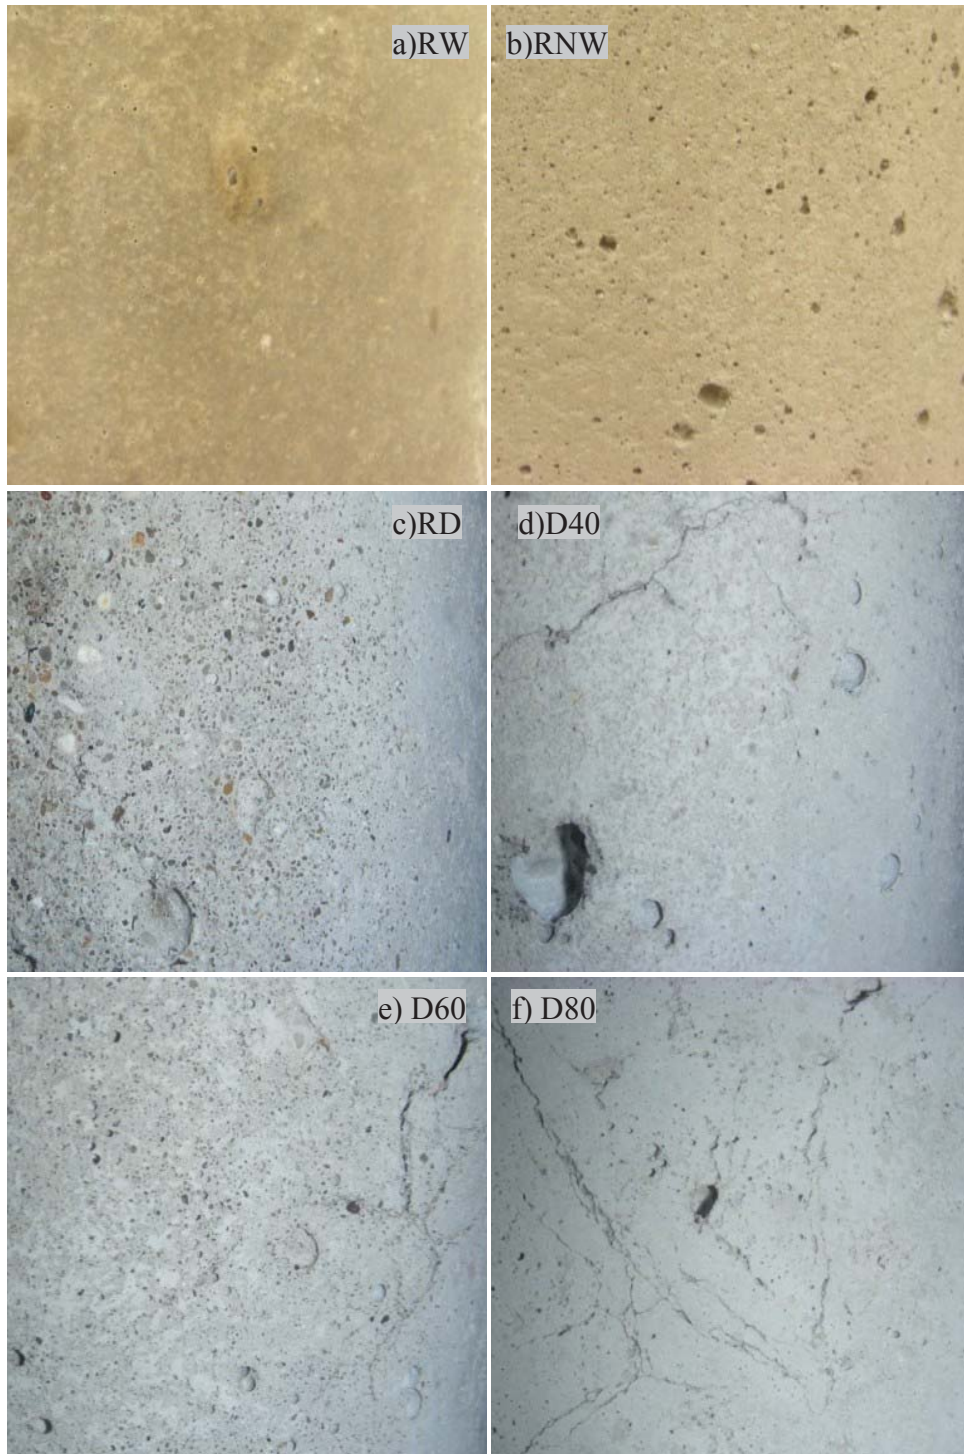
Figure 3.6: Typical surface conditions after F/T cycles

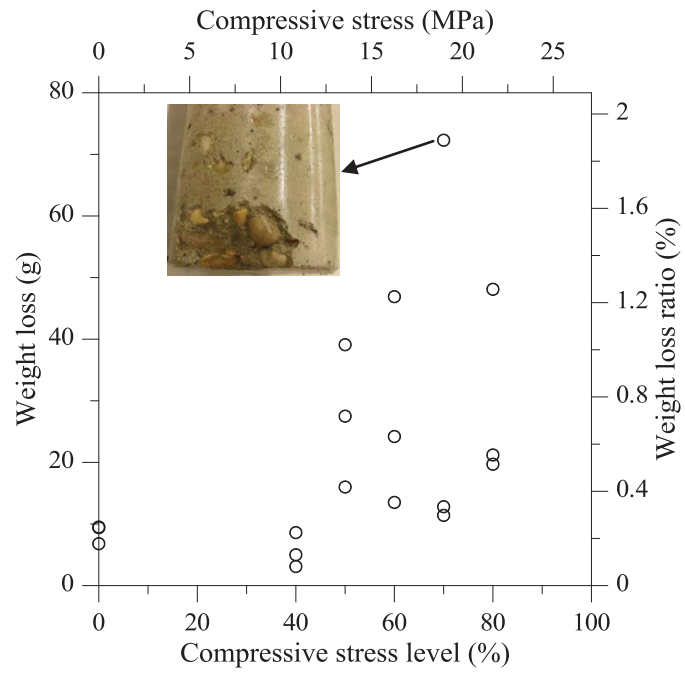
Figure 3.7: Measured weight loss of cylinders after 300 F/T cycles

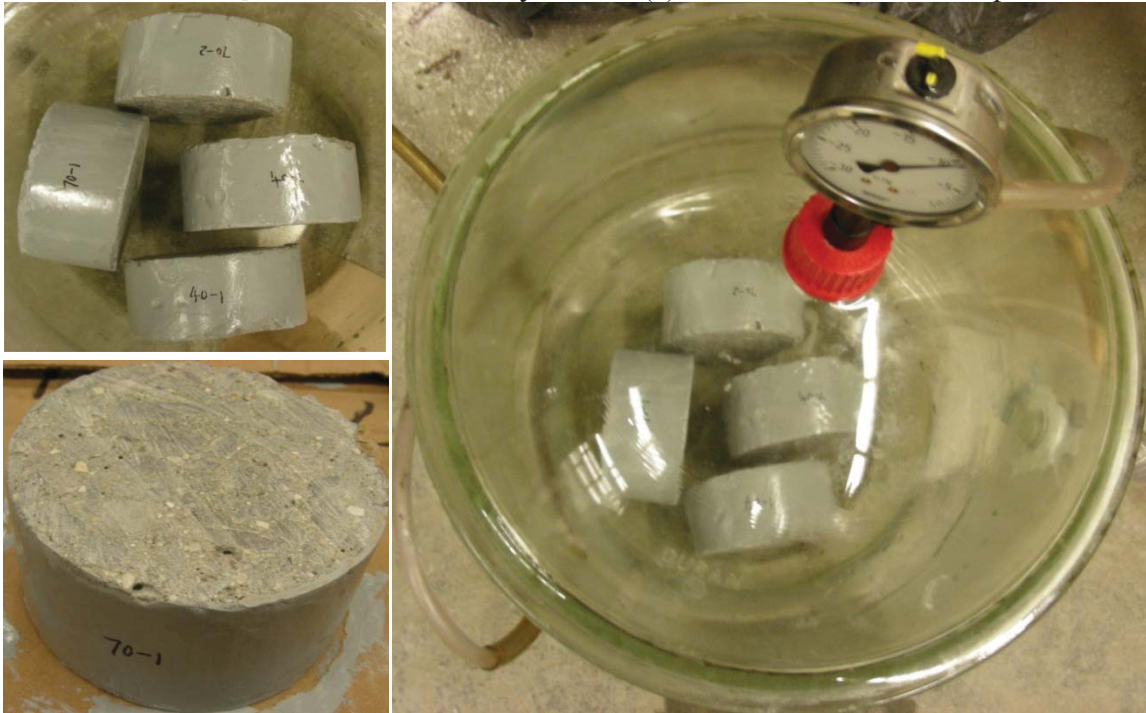
(a) before F/T cycles (b) after F/T cycles (c) cut 2-inch slice from a specimen

(d) coated specimens (e) specimens under conditioning

Figure 3.8: Preparations for RCIP test

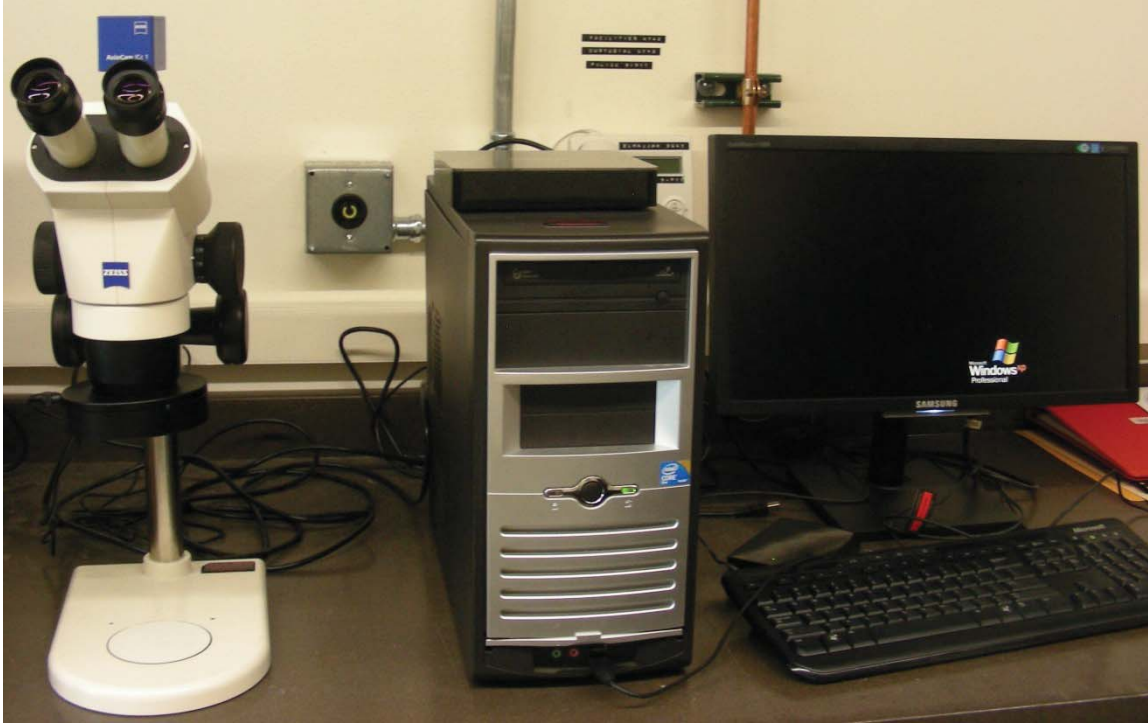
Figure 4.1: Optical microscope used to observe microcracks in samples

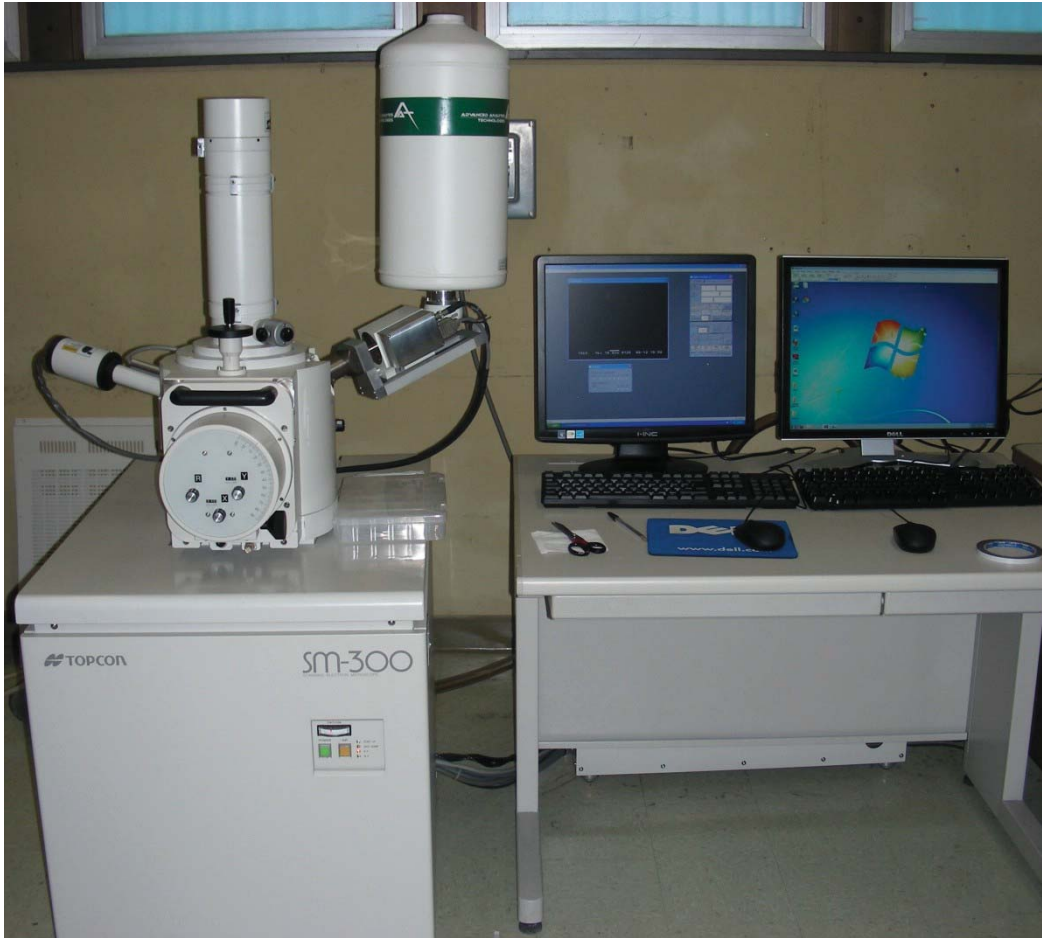
Figure 4.6: Using (Topcon SM300) SEM techniques to capture the microstructures of concrete
