Title: Corrosion Protection and Steel-Concrete Bond Improvement of Prestressing Strand

CFIRE 05-12
December 2012

National Center for Freight & Infrastructure Research & Education
Department of Civil and Environmental Engineering
College of Engineering
University of Wisconsin–Madison

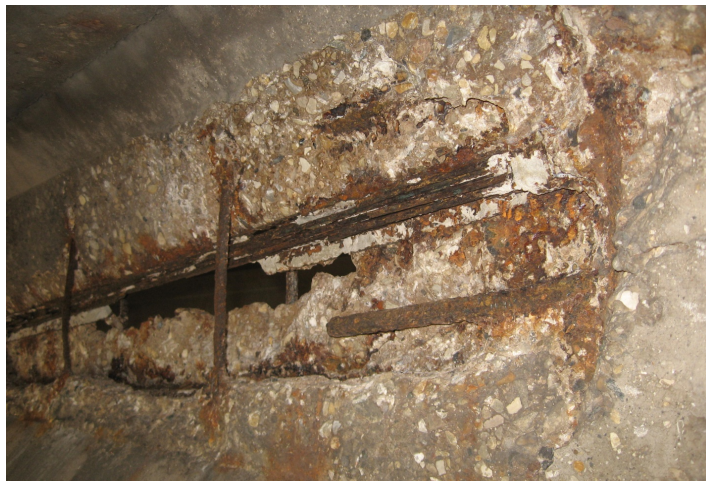
Figure-1. 1 Strand and rebar deterioration in US 45 bridge in Milwaukee

The loss of even one or a few strands has a great impact on prestressed members since their ability to sustain load relies on the tensile strength of the tendons. Weakening of the steel and resultant concrete cracking causes loss of prestress transfer and failure of the member. For example the girder in Figure 1.1 shows clear signs of concrete spalling caused by the corrosion products of rusting strand in the US-45 Bridge in Milwaukee.

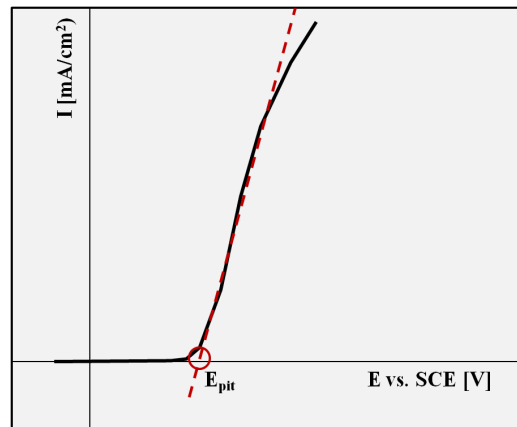
Figure-3. 2 Determination of Critical Pitting Corrosion Potential using polarization plots

For a given chloride concentration and solution pH the more positive the critical pitting potential, the more resistant the metal or alloy is to pit initiation[21]. There is more than one way to read the pitting potential from a polarization curve. However, since this number is only good to compare different metals or anticorrosion treatments any way can be valid. One of the criterions for interpreting this parameter is shown in Figure 3.2. The critical pitting corrosion potential is taken as the potential value where a tangent to the polarization curve (in the positive current density region) intersects the x-axis, as shown.

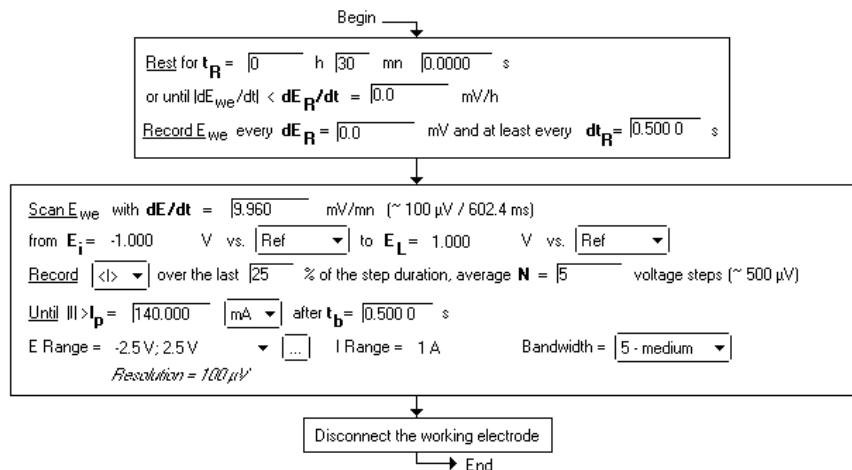
Figure-4. 4 Potentiodynamic Anodic Polarization Program

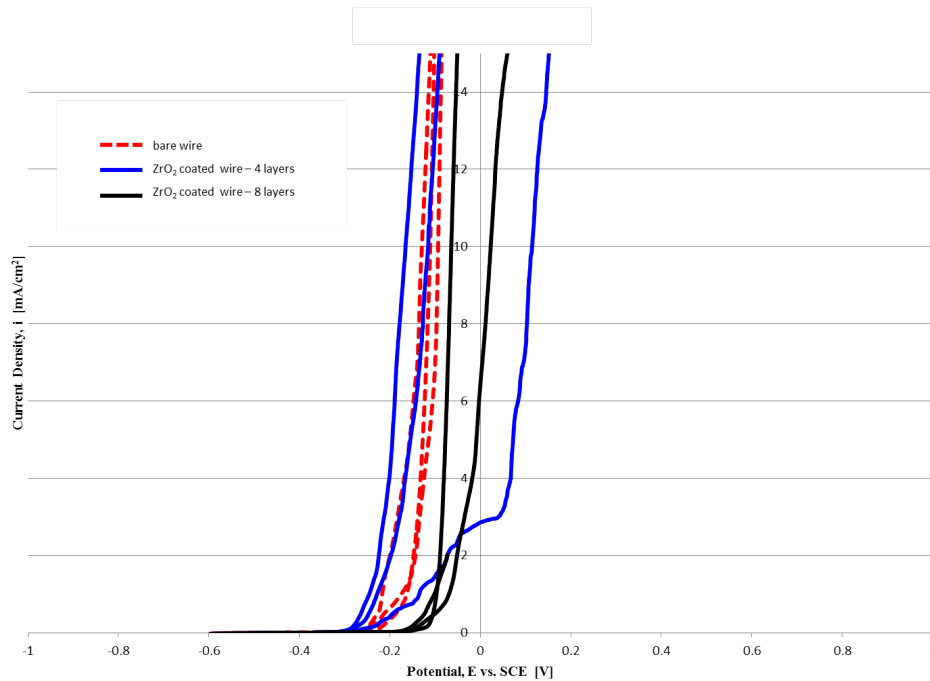
Figure-4. 5 Polarization Curves: bare wire (red), coated with 4 layers of ZrO_2 (blue), coated with 8 layers of ZrO_2 (black) with no surface treatment.

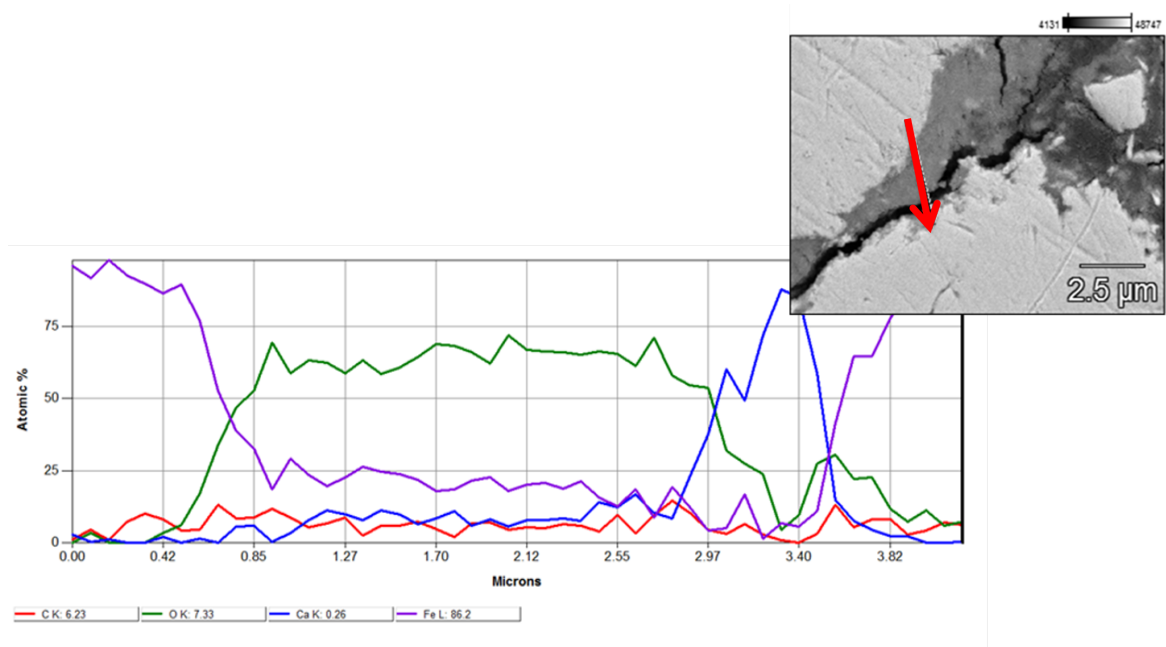
Figure-4. 9 EDS Spectra in atomic % of line scan vector shown in photo (top). The x-axis corresponds to the length of the line vector. Light areas are indicative of iron while gray areas are generally oxides.

The presence of calcium was detected in small quantities by the *X-ray Line Scan Energy Dispersive Spectroscopy (EDS)* technique in which a beam follows a path drawn on the image and produces a plot of elemental atomic percentages along the length of the vector line. The atomic percentage of iron (Fe), carbon (C), calcium (Ca) and oxygen (O) are plotted in Figure-4.9. The graphs represent quantity of elements found in a 0.4mm vector line. From the graph and vector line it can be seen that light areas correspond to higher atomic percentages of iron while darker areas contain around 65% oxygen, which indicates the presence of oxides. Some presence of calcium (23 atomic %) can be observed along the vector line in Figure-4.10. The Fe and O counts indicate the presence of pure iron and magnetite (Fe_3O_4).

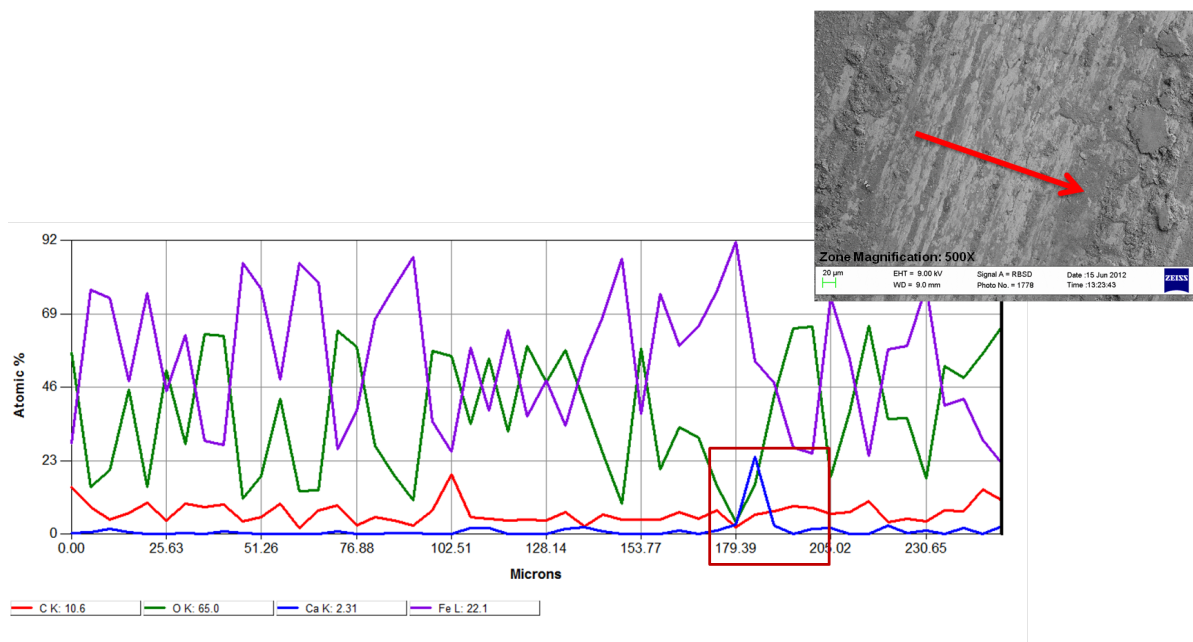
Figure-4. 10 EDS Spectra in atomic % of line scan vector shown in photo (top). The x-axis corresponds to the length of the line vector. Blue peak indicates presence of calcium

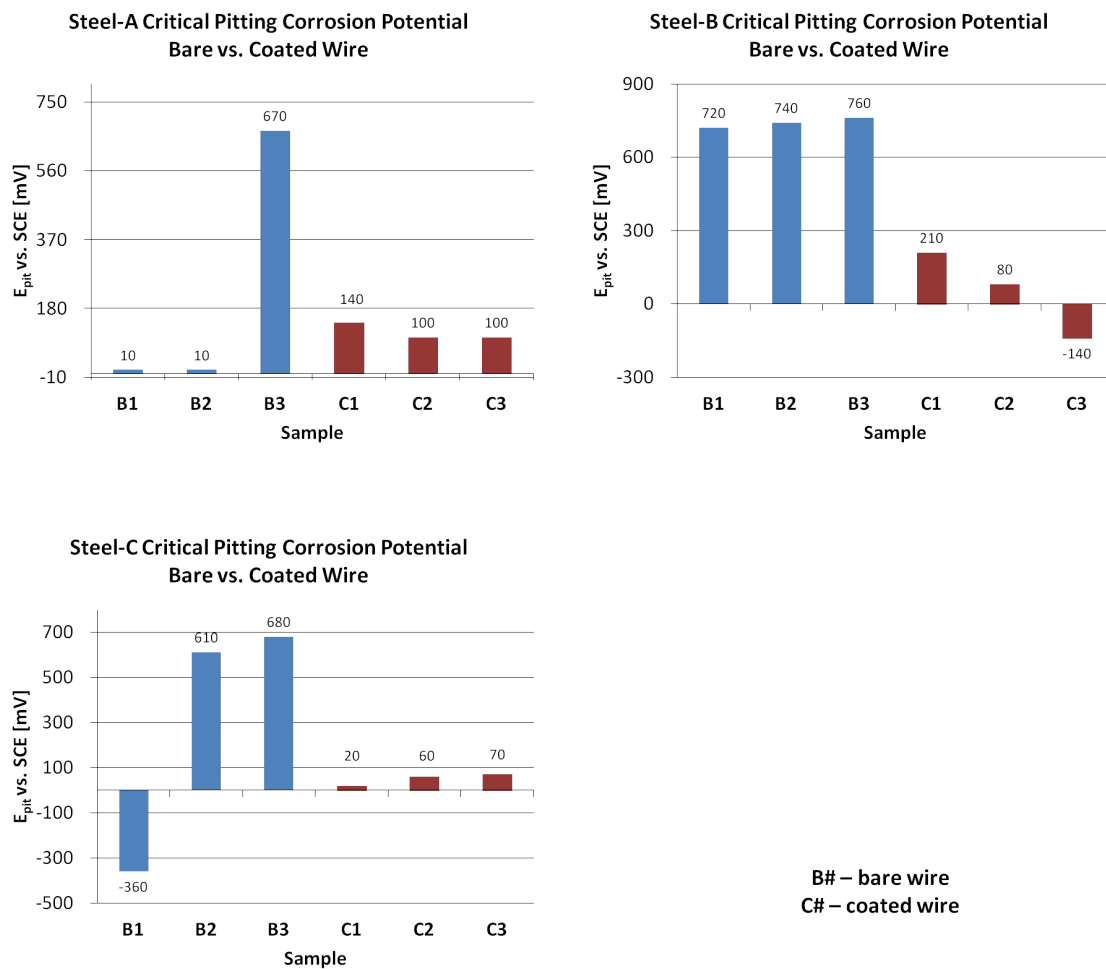
Figure-5. 5 Critical Pitting Potentials of stretched wires

The average pitting potential of bare and coated wires is plotted in Figure 5.5 for manufacturers A, B and C. In this case there is no increase in critical pitting potential values of coated samples with respect to bare wire. Coated wires performed poorly for all steels. The difference of averaged pitting corrosion potential values is tabulated in Table 5.4.

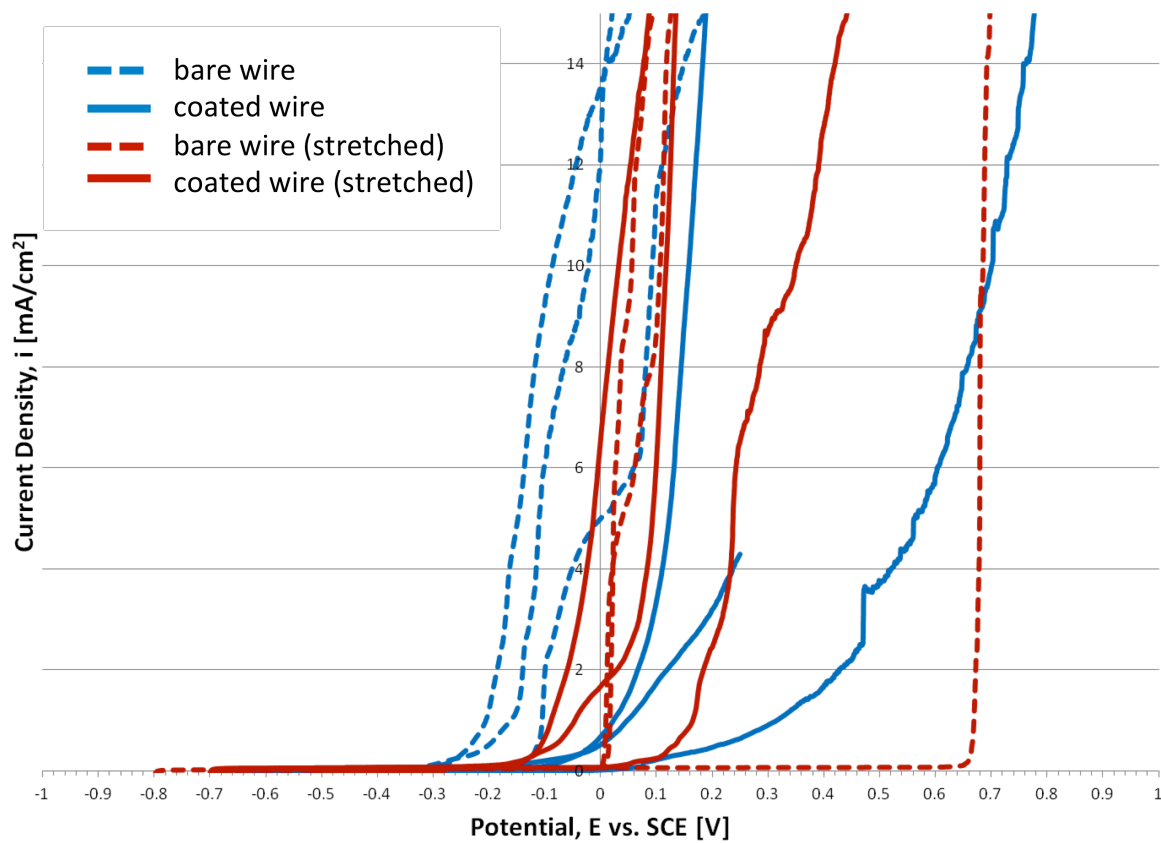
Figure-B. 1 Polarization Curves for Steel-A

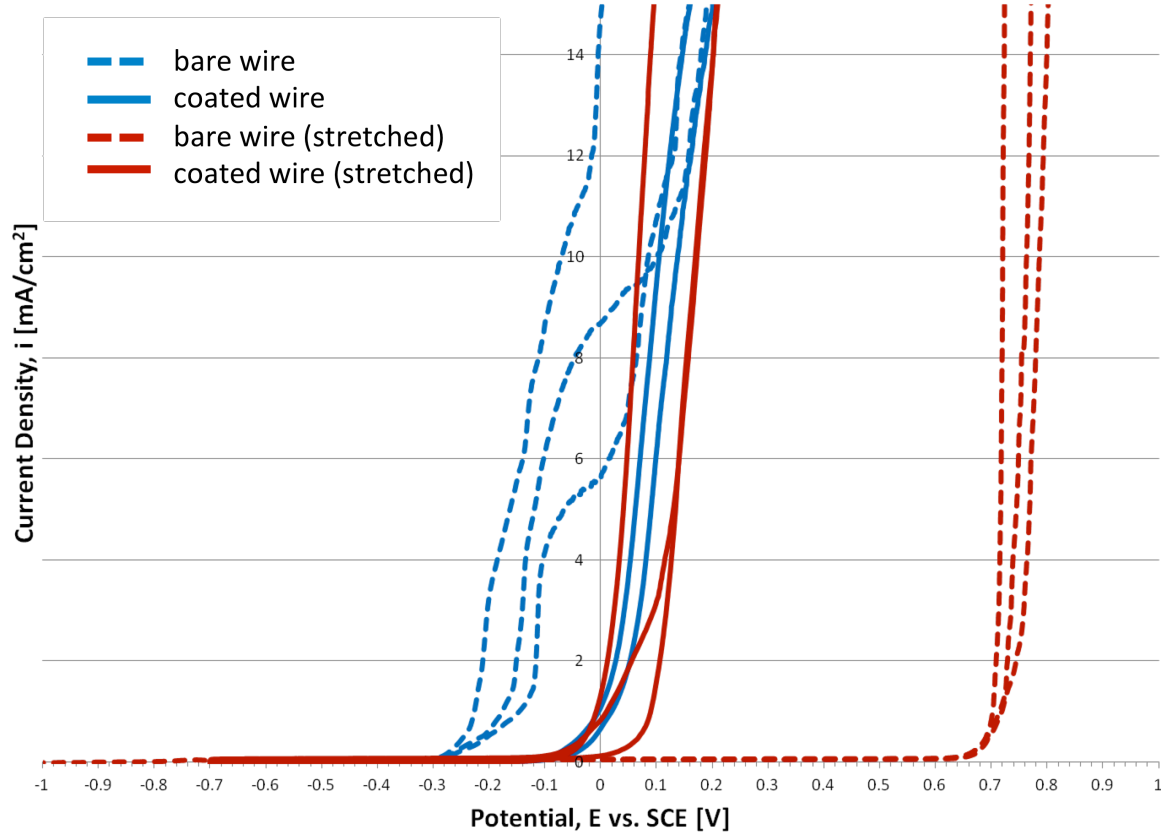
Figure-B. 2 Polarization Curves for Steel-B

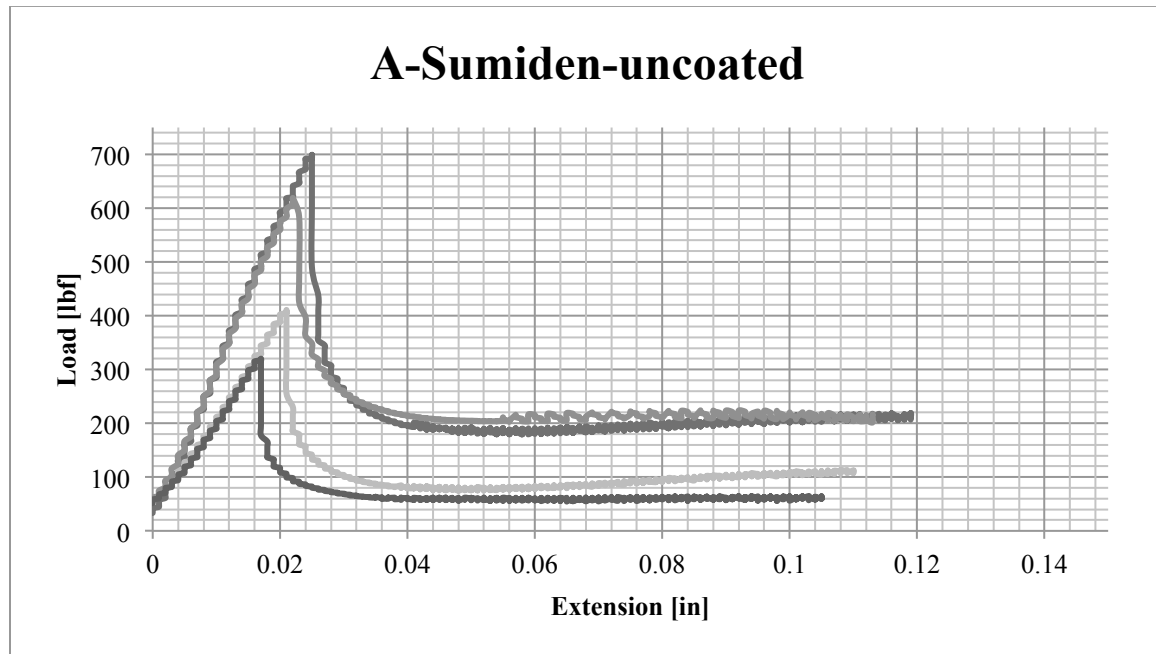
Figure-C. 1 Pull-Out Tests Plot - Steel-A: Uncoated

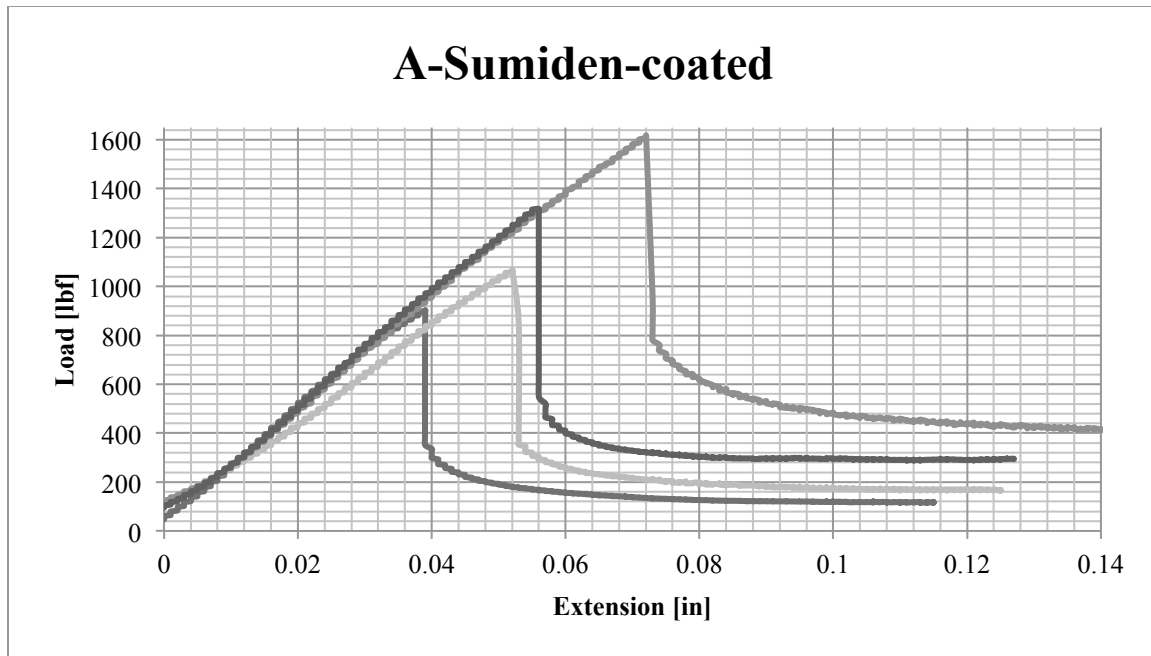
Figure-C. 2 Pull-Out Tests Plot - Steel-A: Coated

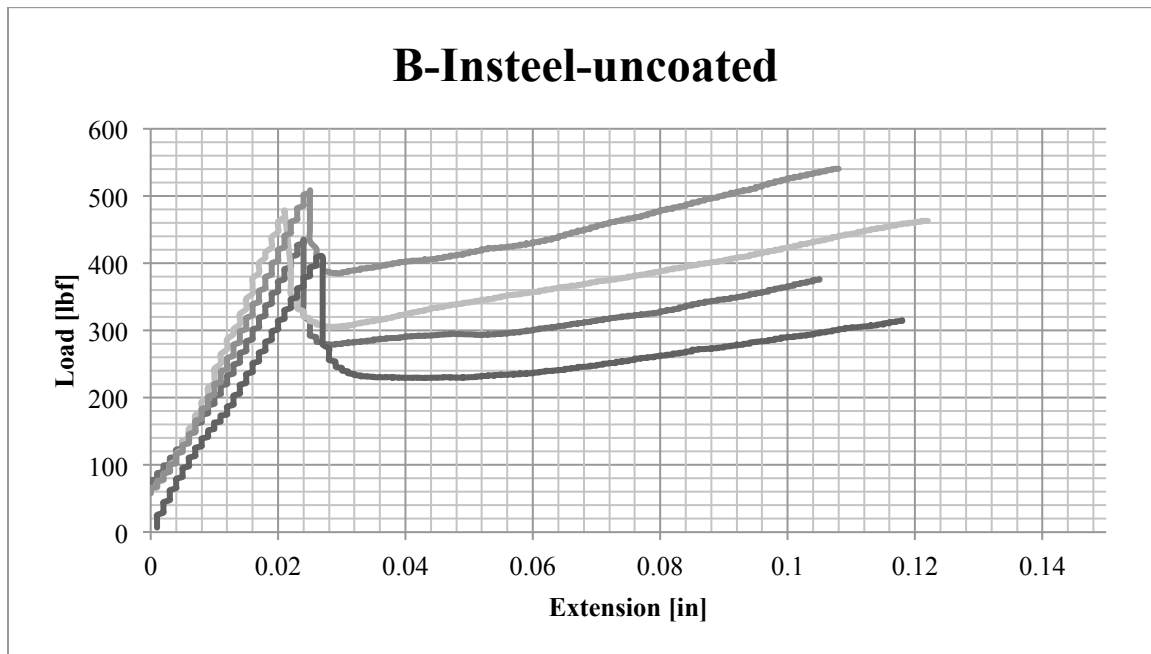
Figure-C. 3 Pull-Out Tests Plot - Steel-B: Uncoated
